# **Ervinton Elementary School Facilities Condition Assessment Report**

Dickenson County Public Schools

**Prepared by  
OWPR, Architects and Engineers  
200 Country Club Drive  
Blacksburg, Virginia**

Field investigation was performed on February 7, 2018

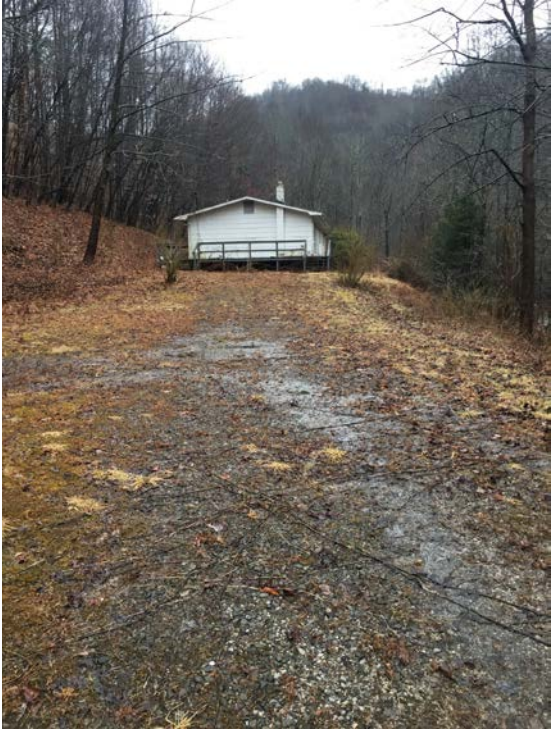
- Recommendation (5 year): Maximizing on-site parking by expanding existing parking lots and creating new parking areas. Consider replacing the dilapidated janitorial house with additional parking.
- Recommendation (10 year): Maintenance

Janitors house and gravel drive

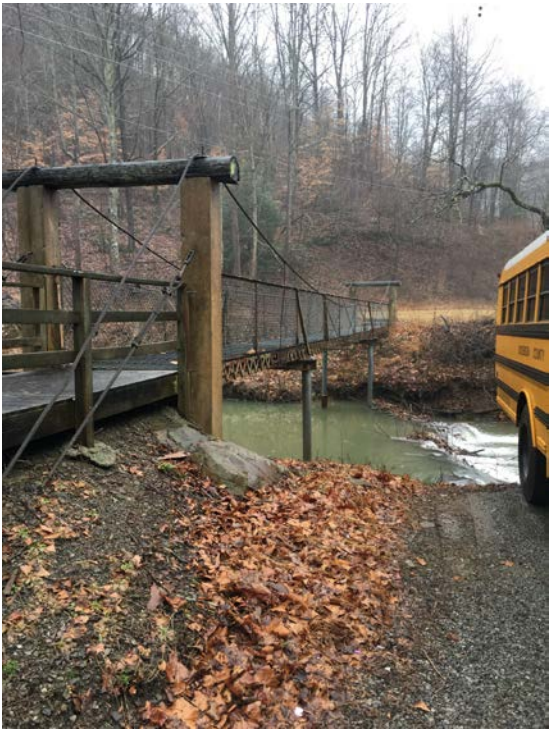
Accessory Structures: There is a storage building behind the school and a storage building adjacent to the gym in fair condition. The pedestrian bridge to the west of the school which gives access to the playground across the stream is old, rusted and appears to be in poor condition. The old janitorial house is deteriorated and poses a safety issue to anyone who trespasses into the abandoned building.

Pedestrian bridge

- Recommendation (5 year): Repair the pedestrian bridge.
- Recommendation (10 year): Maintenance

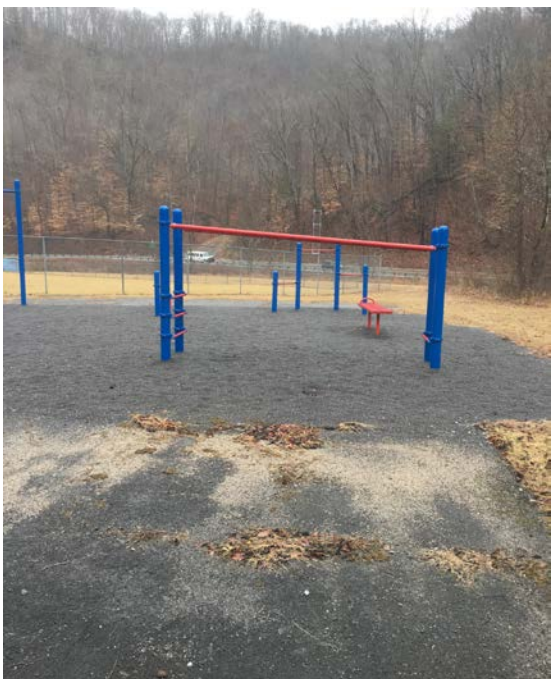
Playgrounds / Stationary Play Equipment: There is no separation between year PreK-1 equipment and Year 2-5 equipment. Majority of equipment is in good condition. Fencing around the perimeter of the playground provides student safety. Equipment shows signs of vinyl coating wearing down. Wood equipment has aged, but still in fair condition. Play areas require fresh mulch in lieu of gravel. Exercise equipment across the street is in good condition, but rarely used.

Playground

- Recommendation (5 year): Maintenance
- Recommendation (10 year): Maintenance.

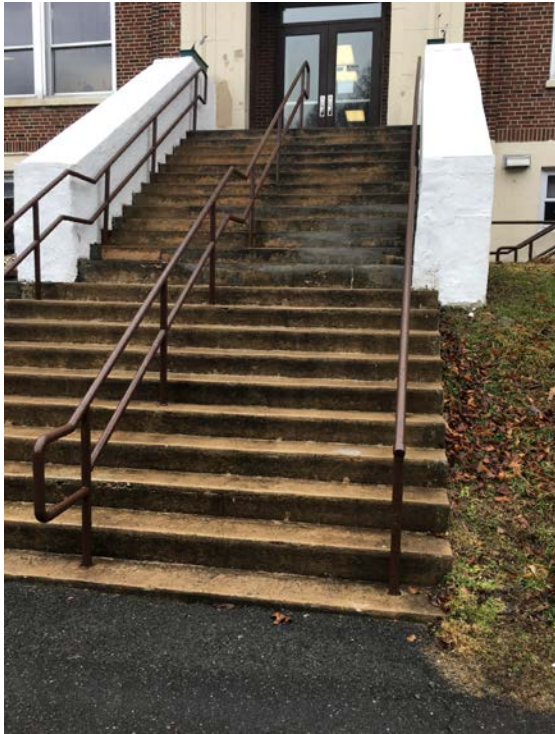
Stairs, Ramps, and Railings: Concrete stairs at the front entrance to the school are in poor-to-fair condition. The railings are in fair condition. Concrete stairs to the playground and paved play area at the front of the school are in poor condition and deteriorating. The handrails are too low and unstable.

Main entry stairs and rails

- Recommendation (5 years): Maintain and repair concrete stairs as needed. Replace handrails.
- Recommendation (10 years): No action

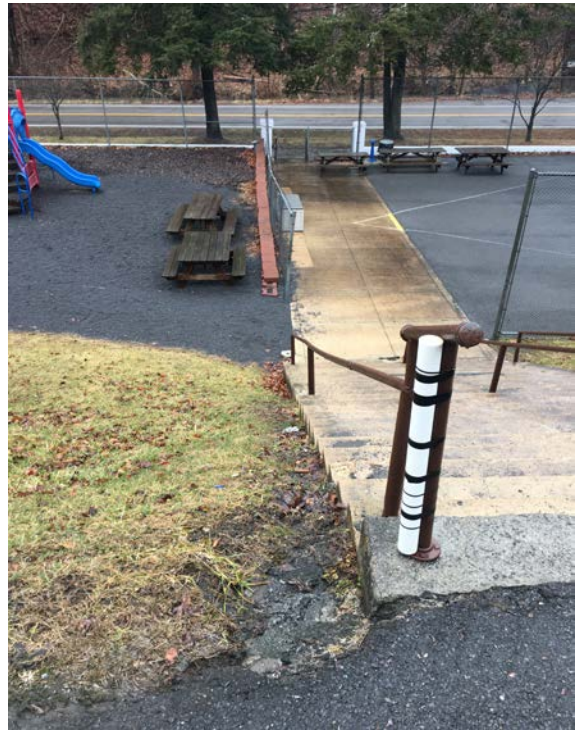
Stairs to playground

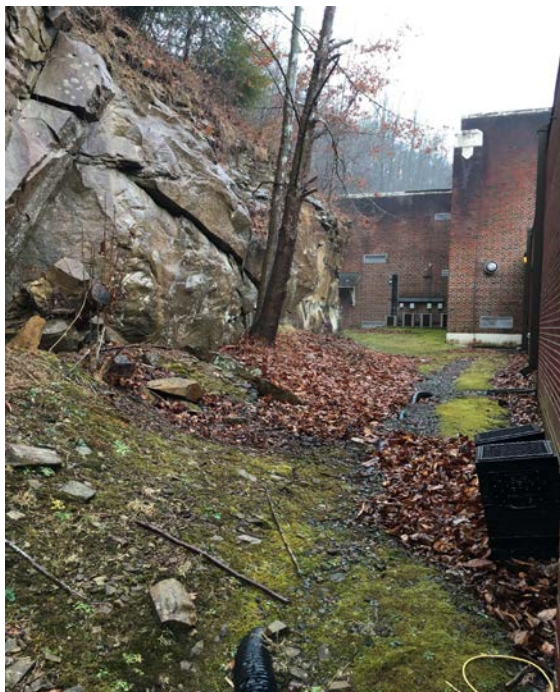
Slopes, Ponding, and other Drainage Issues: Upstream runoff at the back of the school causes drainage issues. There are multiple locations at the rear of the building with significant ponding. Staff indicates moisture and drainage issues in school basement. There is major ponding at the playground areas.

Rear of building/downspouts

- Recommendation (5 year): Collect all downspouts at the rear of the building and pipe underground towards the service area and down to the road. Provide small nylonplast grate inlets as necessary to prevent ponding water.
- Recommendation (10 year): None

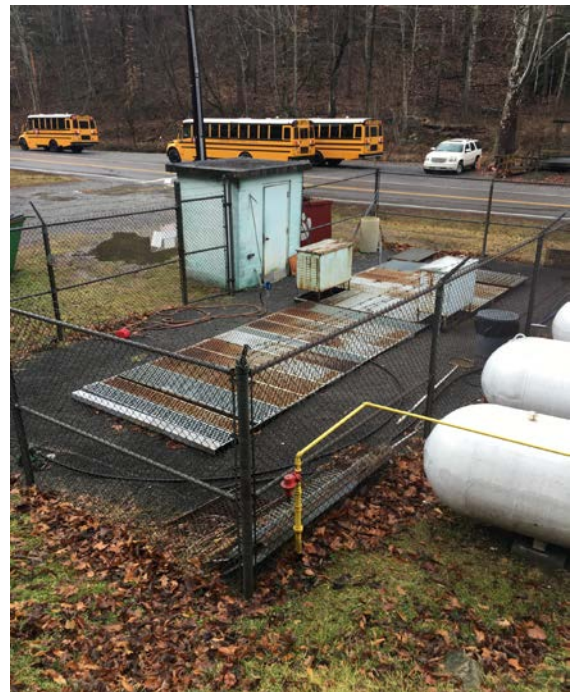
Wastewater treatment plant

- Recommendation (5 year): The sanitary sewer lines should be flushed clean and videoed to check for necessary repairs. The sewage plant should be inspected by a wastewater engineer to ensure system is functioning properly.
- Recommendation (10 year): Replace sewage plant.

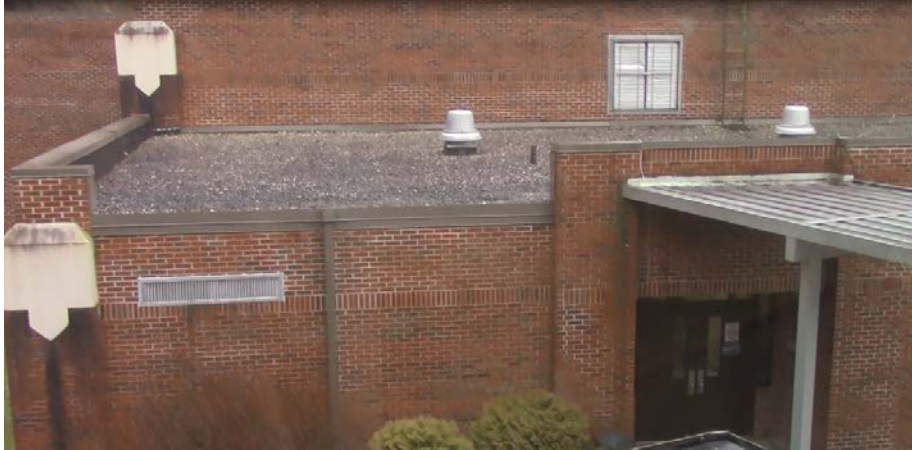
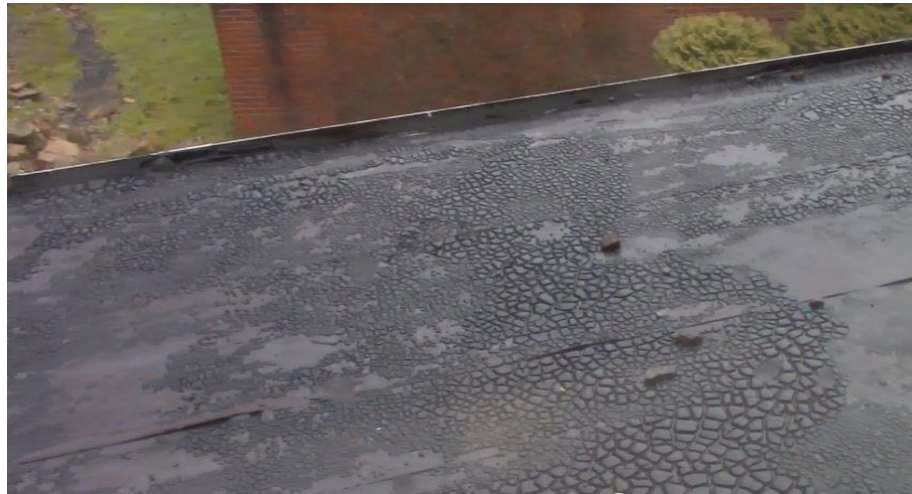
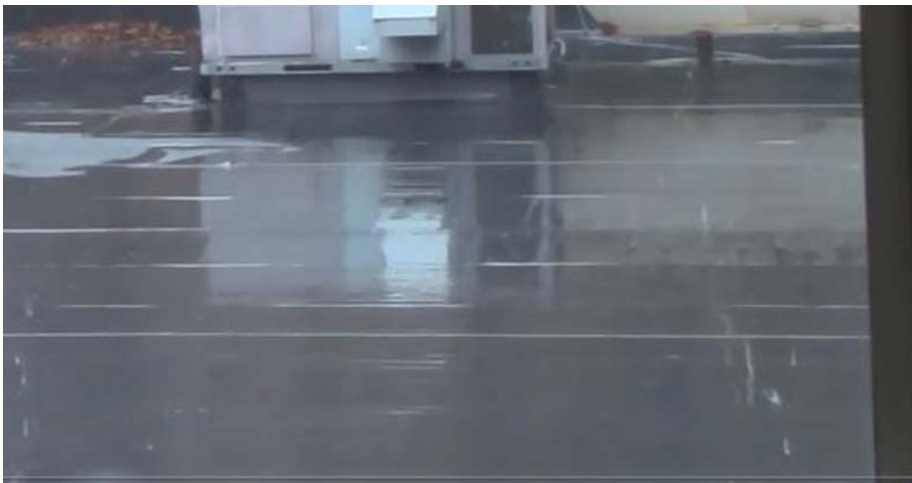
Roof: The roof on the Original Building and Classroom Addition appears to be a built-up tar and felt roof system. The Cafeteria Addition appears to be an EPDM single-ply membrane that appears to have been installed recently as the original roof was a ballasted single-ply membrane. This roof appears to be in good condition. The Gym Building roof is a ballasted single-ply membrane. This roof appears to have reached the end of its useful life.

Gym building roof

1967 addition roof

Cafeteria roof

- Recommendation (5 year): Replace roof on Original Building, Classroom Addition, Cafeteria Addition and Gym Addition with a new 60 mil, fully adhered EPDM single-ply membrane over new insulation.
- Recommendation (10 year): Maintenance

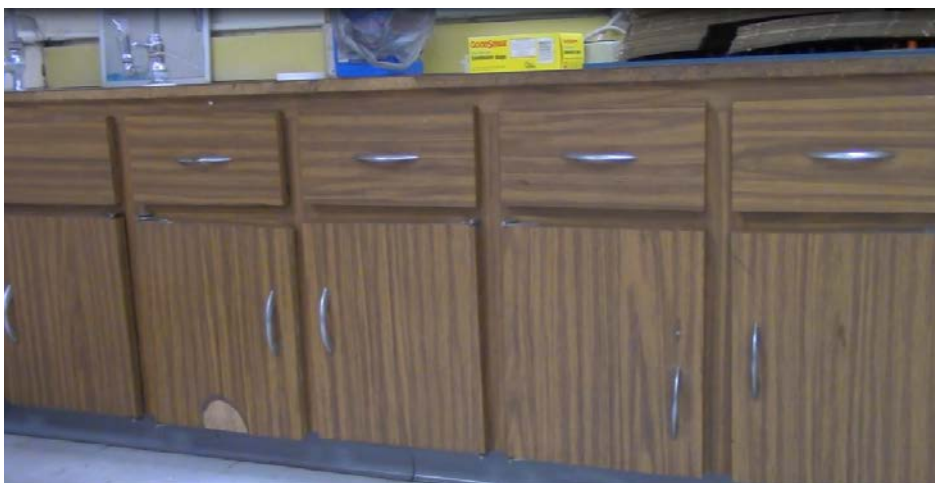
Casework (cabinets): These are in generally poor-to-fair condition. Most casework is not handicap accessible.

Typical classroom casework

- Recommendation (5 year): Maintenance
- Recommendation (10 year): Replace all casework
